Manhole Inspection Summary

Manhole # S59K__003MH

Insp Date: **7/23/08 2:11 PM**

Location Address: **rear 646 s newkirk st**

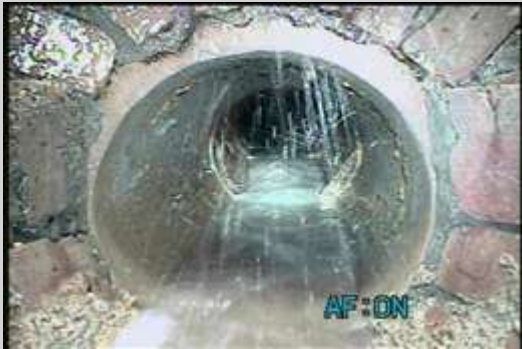
12 O'Clock Outflow

10 in. Circular Gravity Sewer
Pipe Out @ 12 O'Clock

Pipe Material: **Clay** ☐ Pipe Lined

Invert Depth: 8.00 (ft.) Flow Characteristics: **Fast**

Deposits: ☒ None ☐ Mud ☐ Sludge ☐ Debris ☐ Grease

Infiltration: **None** Pipe Seal Cond: **Unknown**

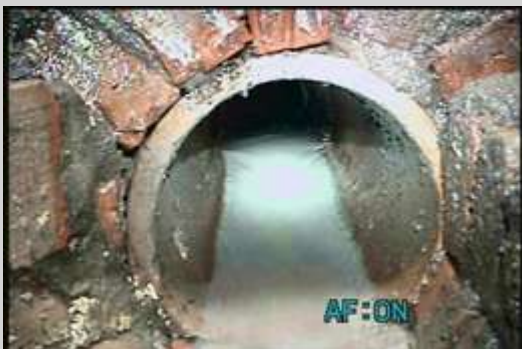
3 O'Clock Inflow

8 in. Circular Gravity Sewer
Pipe In @ 3 O'Clock

Pipe Material: **Clay** ☐ Pipe Lined

Invert Depth: 7.83 (ft.) Flow Characteristics: **Fast**

Deposits: ☒ None ☐ Mud ☐ Sludge ☐ Debris ☐ Grease

Infiltration: **None** Pipe Seal Cond: **Unknown**

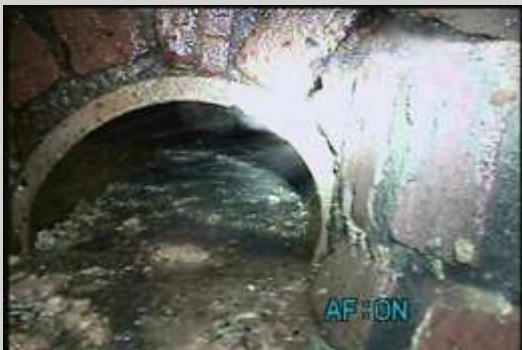
9 O'Clock Inflow

8 in. Circular Gravity Sewer

Pipe In @ 9 O'Clock

Pipe Material: **Clay** ☐ Pipe Lined

Infiltration: **None** Pipe Seal Cond: **Unknown**
